# Manhole Inspection Summary

Manhole # S27K\_\_011MH

Insp Date: **6/3/08 11:25 AM**

**Location** Address: **825 Ramsey St** Cross Street: **S Poppleton St**

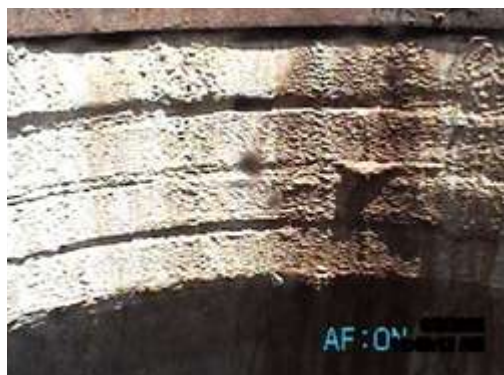
Defect 4

Infiltration: ☐ None ☒ **Joint** ☐ Cracks ☐ Mortar ☐ Roots ☒ **Wall**

frame-chimney infiltration

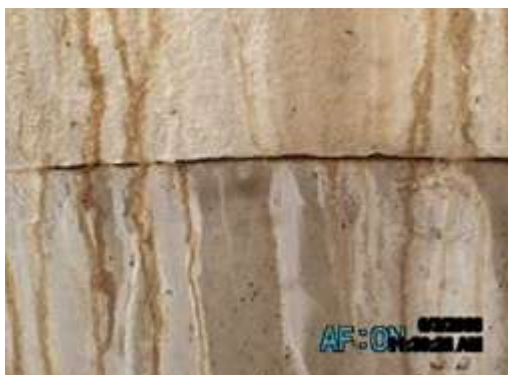
Defect 3

Infiltration: ☐ None ☒ **Joint** ☐ Cracks ☐ Mortar ☐ Roots ☐ Wall

corbel-barrel connect infiltration from gap

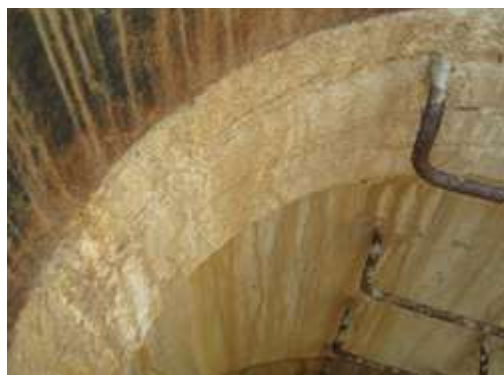
Defect 2

**Frame** Offset: **0** (in.) Condition: ☐ Sound ☐ Cracked ☒ **Leaks**

infiltration frame-lid

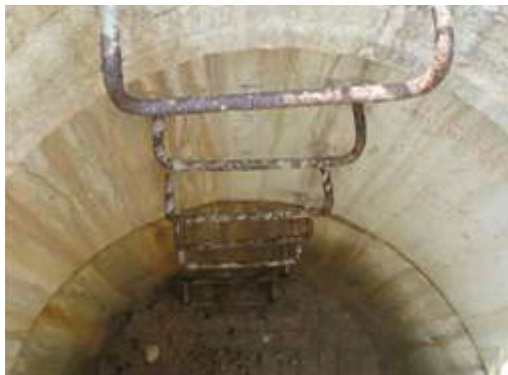
### Defect 1

**Steps** Count: **7** Missing: **0** ☒ **Corroded**

corroded rungs

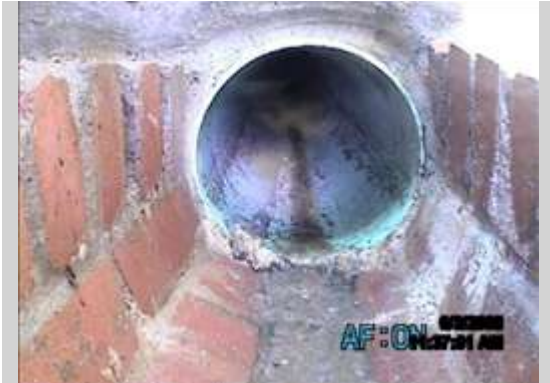
12 O'Clock Outflow

Pipe Height: **8.4** (in.) Rod and Bar (Angled)  
Pipe Material: **PVC** ☐ Pipe Lined  
Invert Depth: **8.07** (ft.) Flow Characteristics: **None**  
Deposits: ☒ None ☐ Mud ☐ Sludge ☐ Debris ☐ Grease  
Silt Depth: **0** (in.) Deposits Extent:  
Infiltration: **None** Pipe Seal Cond: **Sound**

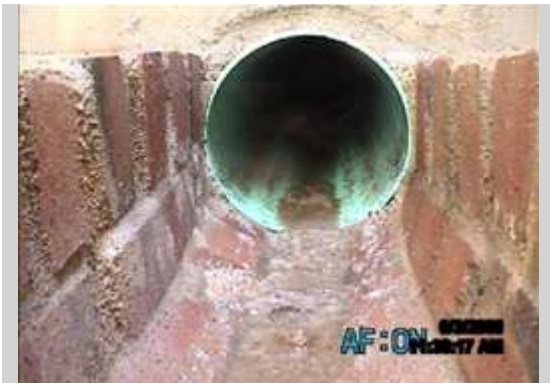
6 O'Clock Inflow

Pipe Height: **8.4** (in.) Rod and Bar (Angled)  
Pipe Material: **PVC** ☐ Pipe Lined  
Invert Depth: **8.05** (ft.) Flow Characteristics: **None**  
Deposits: ☒ None ☐ Mud ☐ Sludge ☐ Debris ☐ Grease  
Silt Depth: **0** (in.) Deposits Extent:  
Infiltration: **None** Pipe Seal Cond: **Sound**
